**MILLIKEN CLEAN COAL TECHNOLOGY  
DEMONSTRATION PROJECT**

**HEAT PIPE PERFORMANCE – FINAL REPORT**

Prepared by

CONSOL Inc.  
Research and Development  
4000 Brownsville Road  
Library, Pennsylvania 15129-9566

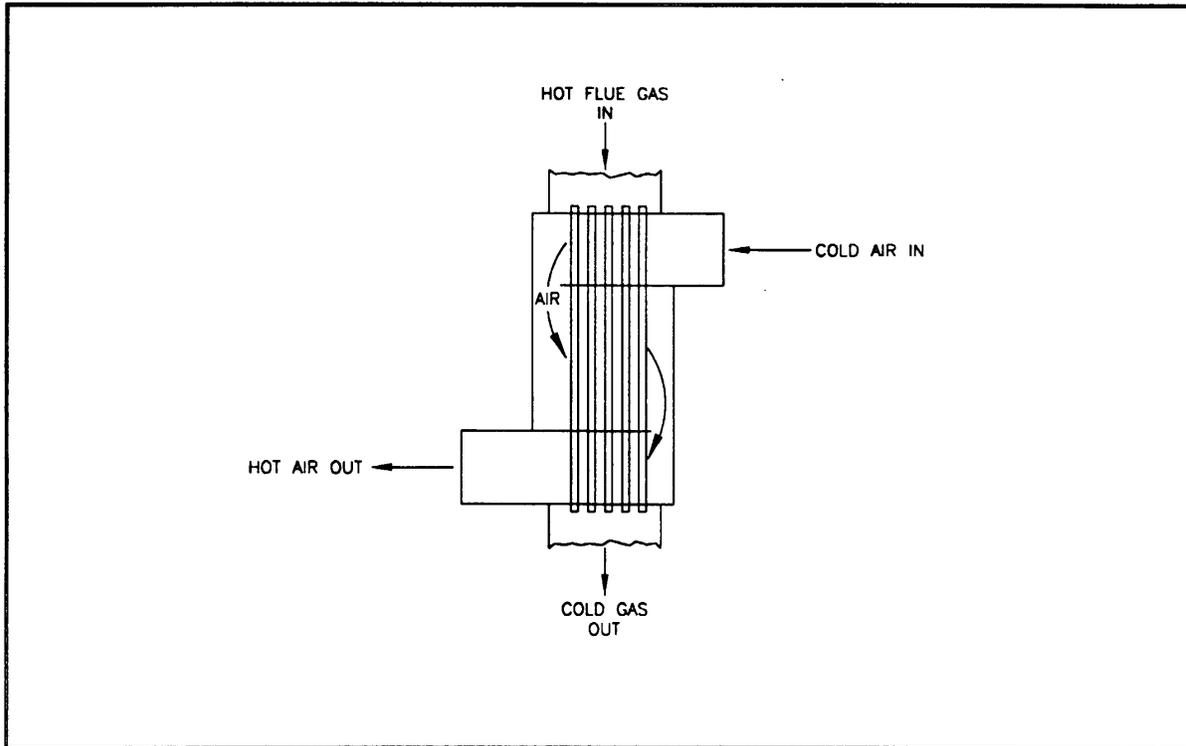
**Figure 1.** Tubular recuperative air heater, three air pass - counter flow unit.

In a recuperative heat exchanger, the flue gas and air streams are separated by the heat transfer surface. Heat energy from the flue gas is transferred directly across the heat transfer surface to the air. Tubular air heaters (Figure 1) in which the hot flue gases pass through metal tubes with air passing around the outside of the tubes are the most common type of recuperative heat exchanger used. These units provide a passive operating design with no moving parts and, when new, can have a low or zero leakage between the air and flue gas sides. The units are, however, physically large as compared to other types of air heaters and are prone to cold-end corrosion and fouling if tube wall temperatures drop below the acid dew point of the flue gas. With time, air leakage increases as more and more tubes corrode through. With acid condensation, serious fouling can occur due to the formation of sticky fly ash/acid poultrices. Poultrice formation can plug tubes. For the remaining open tubes, this increases outlet flue gas temperatures and flue gas side pressure drops.

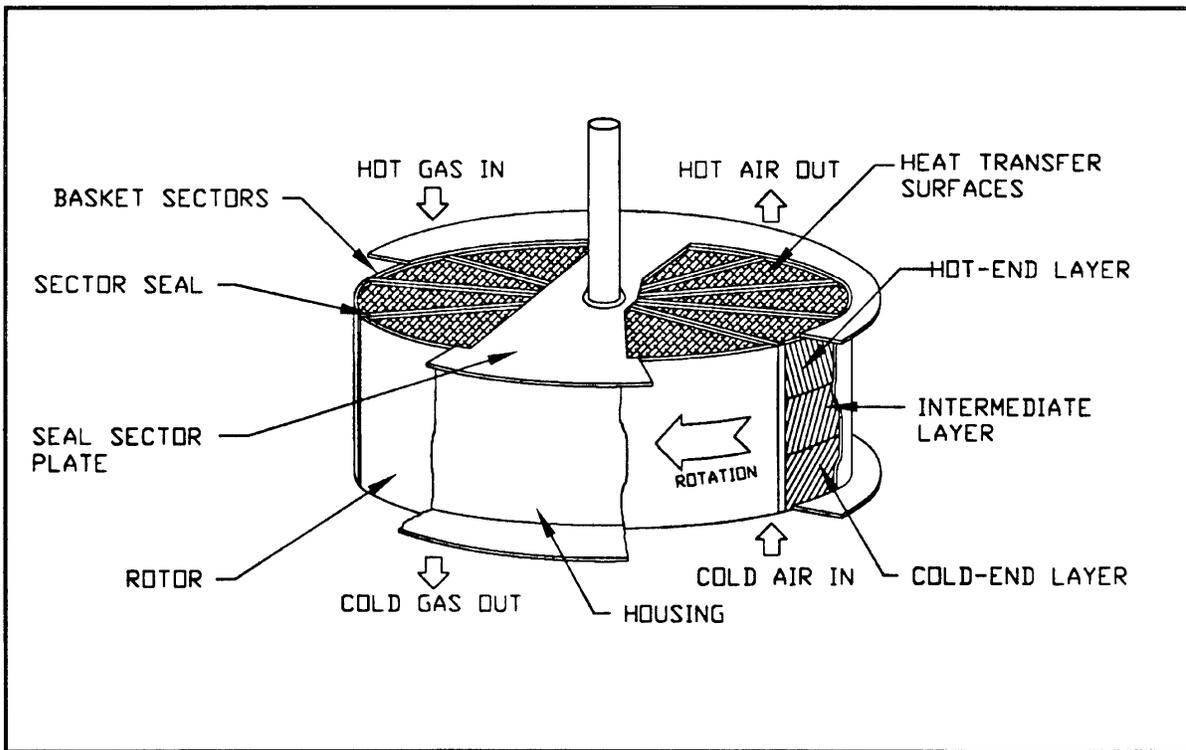
**Figure 2.** Rotating basket (Ljungstrom® type) regenerative air heater.

The rotating wheel (rotor) Ljungstrom type exchanger is the most common type of regenerative air heater used by utilities. In these units, heat is transferred indirectly from the hot flue gases to the cooler combustion air through an intermediate medium, in this case, a basketed rotor containing many corrugated metal plates (Figure 2). The corrugations separate the plates and provide a torturous path for gas or air to flow to improve the heat transfer. The rotor continuously turns through the flue gas and air streams. The metal plates in the rotor baskets absorb sensible heat from the flue gas as the rotor turns through the flue gas side of the exchanger. This heat is transferred to

the air as the hot plates rotate through the air side. The design is compact and provides efficient heat transfer.

Although there are seals around the rotor, leakage from the combustion air side of the exchanger into the flue gas side is perhaps the biggest problem with the design. The leakage occurs in three areas: across the radial seals, in the clearance between the rotor and the metal case, and by entrainment from the basket gas passages as the baskets rotate from the air side into the flue gas side. When new, the air leakage may be as low as 5 percent to 10 percent of the incoming flue gas flow, depending on air heater size and air-to-gas pressure differentials. As the seals wear and the air heater ages, the leakages often increase. If periodic maintenance and replacement of parts are not performed, leakage can increase substantially. The air leakage increases the forced draft fan power consumption since the leaked air bypasses the combustion step and more combustion air must be supplied. The induced draft fan power also increases since the flue gas flow out of the air heater increases by the amount of air leakage. Additionally, the air leakage reduces plant thermal efficiency since less heat is transferred to the combustion air, and increases maintenance on the air heater due to the need to replace or adjust worn seals.

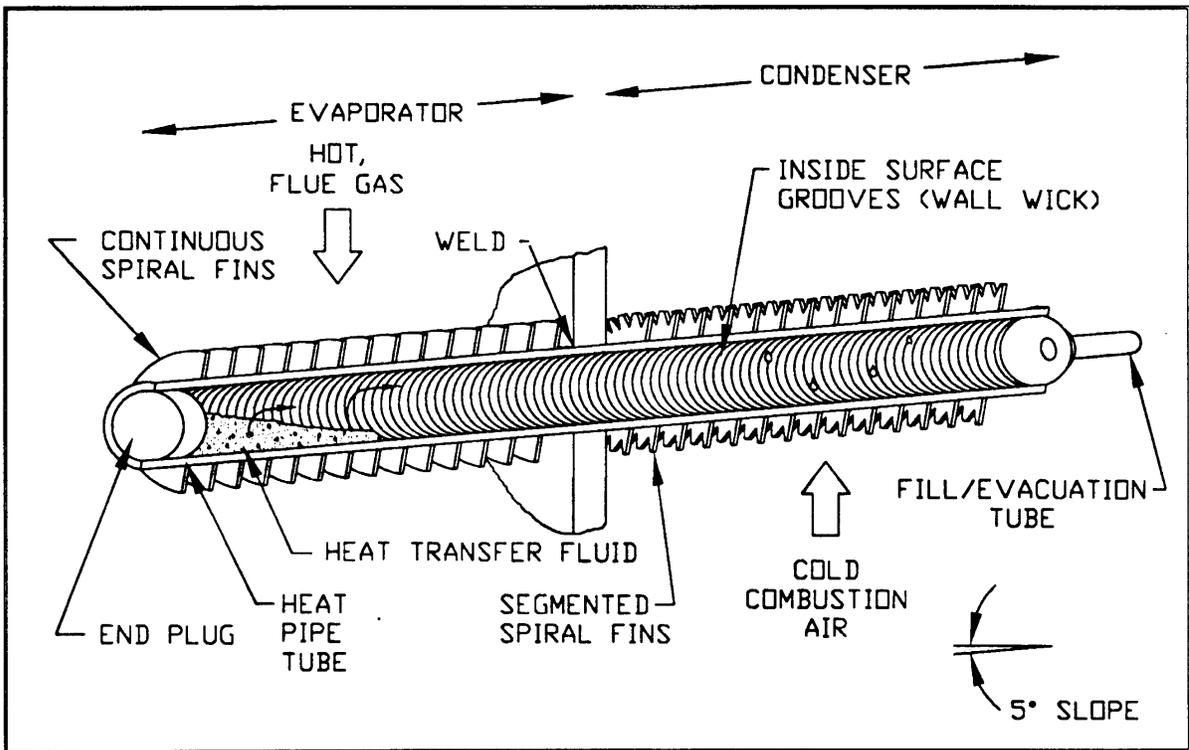
**Figure 3.** Heat pipe cross section.

Depending upon the application, many different materials can be used as working fluids including: liquefied gases, water, hydrocarbons, chlorofluorocarbons, and liquid metals. The working fluid must be operated below its critical temperature, must be compatible with the tube wall material, and must be stable and not decompose under operating conditions. For the Milliken air heater design,

naphthalene was selected for the high temperature sections and toluene used in the intermediate and cold-end sections.

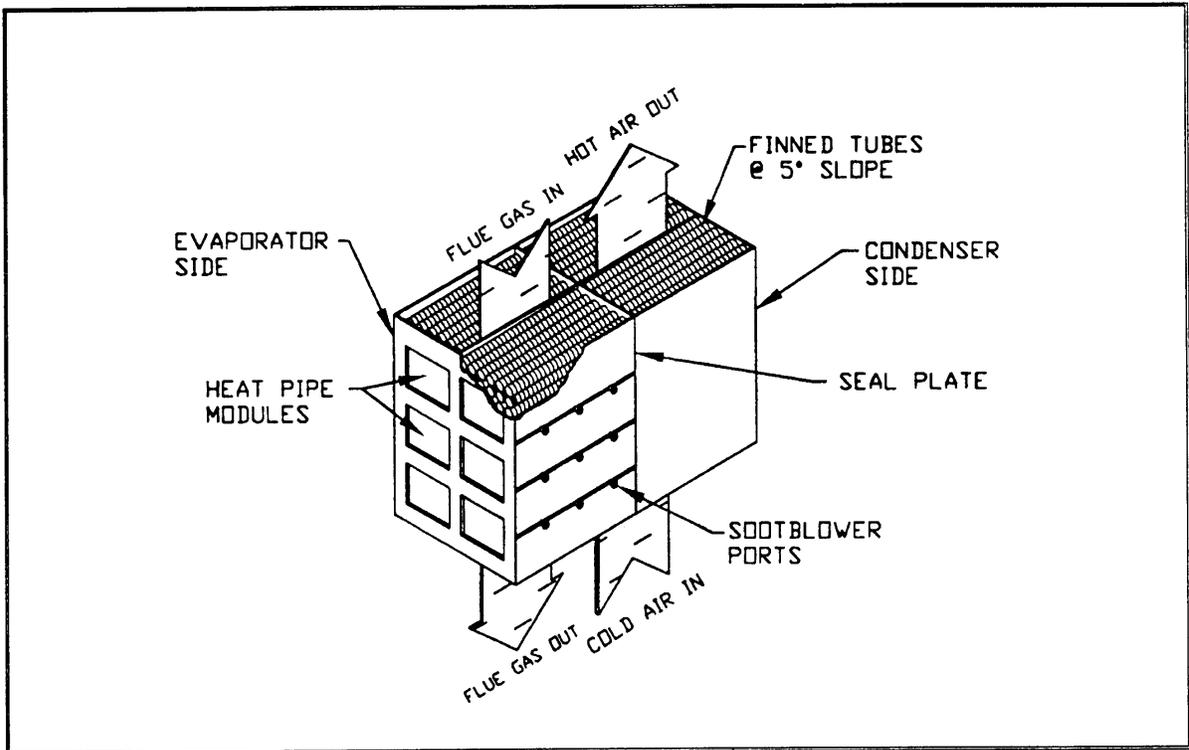
**Figure 4. Typical heat pipe air heater construction.**

A full-scale heat pipe air heater consists basically of two ducts with a common wall. Individual heat pipe tubes extend through the common wall across both ducts (Figure 4). Hot flue gases flow through one duct while cold combustion air flows through the other duct. The tubes are usually seal welded or gasketed in some fashion at the common wall to prevent air leakage between the flue gas and air sections. The ends of the tubes are free to expand or contract as necessary within the duct casing. By extending the individual tube surface through the use of fins, compact units can be designed.

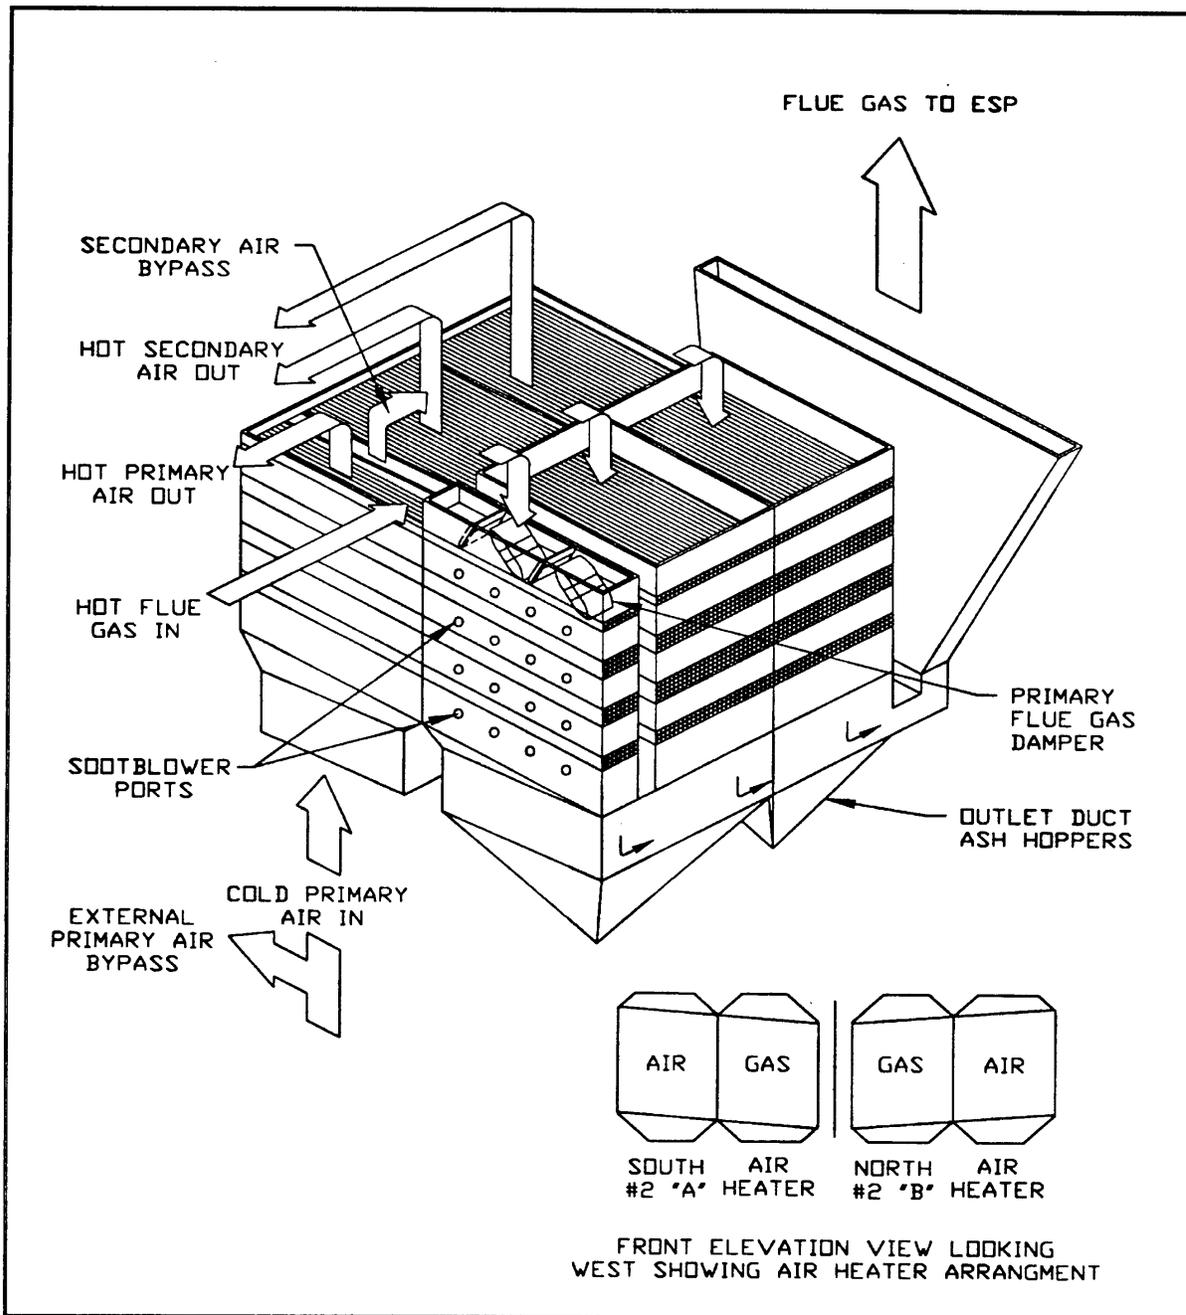
**Figure 5.** Construction of Milliken heat pipe air heaters.

The design of the individual heat pipe air heaters is summarized in Table 1. The general construction is schematically shown in Figure 5 for the Unit 2A heat pipe. As indicated by the insert in Figure 5, the Unit 2B heat pipe is constructed as a mirror image of Unit 2A. Each heat pipe contains 12 (three horizontal - four vertical) shop-fabricated heat transfer modules which are field assembled. The modules are 100 percent seal welded to eliminate air leakage into the flue gas from the ambient environment or across the division wall between the air and flue gas sections. The box-shaped modules sit on duct transition sections which tilt the tubes five degrees above horizontal.

Each heat pipe exchanger weighs approximately 960,000 lbs. The exchangers are each supported on eight legs (not shown in Figure 5) and are each anchored by one leg to the floor. The other seven support legs distribute the load and are free to move on sliding plate foot bearings. Four of the support legs are on guided foot bearings while the other three are on unguided free foot bearings. This accommodates lateral movement due to thermal expansion or mechanical stress. The tops of the heat exchangers are free to move and expand both vertically and horizontally. This movement is accommodated through the use of expansion joints on all ducts attaching to the air heaters.

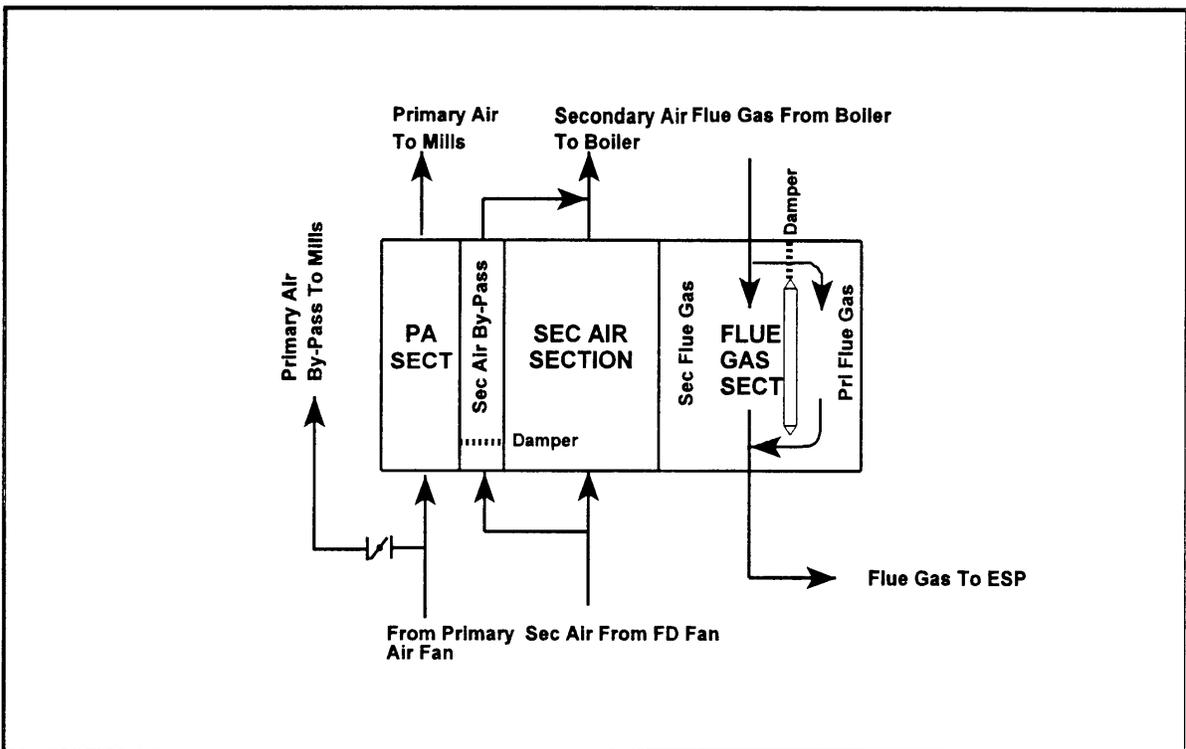
**Figure 6.** Heat pipe process flow streams.

Each heat pipe exchanger is designed to heat both primary and secondary air streams in separate sections. This provides added flexibility for coal drying and in achieving maximum heat recoveries. Bypasses are provided for both the primary and secondary air streams. The primary air bypass is external to the heat pipe and is used to supply tempering air at the coal mills. The secondary air bypass is internal and an integral part of the heat pipe as shown in Figures 5 and 6. An electrically driven damper inside the heat pipe (Figure 6) is used to control the flow through the secondary air bypass. This bypass is used primarily to limit heat transfer from the flue gas section to avoid low cold-end tube temperatures which result in acid condensation. Under certain conditions, bypass control must be limited to prevent overheating of the hottest operating toluene filled tubes.

Two ducts from the boiler supply hot flue gases to the heat pipe air heaters, one duct to each air heater. The flue gases approach the air heaters through horizontal ducts. A set of ladder vanes inside the ductwork hood, which is mounted on top of each heat pipe, redirects the flue gas flow vertically downward to the heat pipe tube banks. The tube banks are split into one primary and two secondary flue gas sections. Gas distributes to the sections based on the pressure drop through the sections. When the air heaters were originally installed, the primary flue gas sections did not have inlet dampers. NYSEG later installed louvered dampers to provide better temperature control and reduce the potential of overheating the hottest toluene filled tubes. Closing the dampers reduces the flow through the primary flue gas section and increases the flow through the secondary flue gas sections. However, primary flue gas flow adjustments have little effect on the overall secondary section flows since the primary gas flow is normally only about one-eighth the secondary flow.

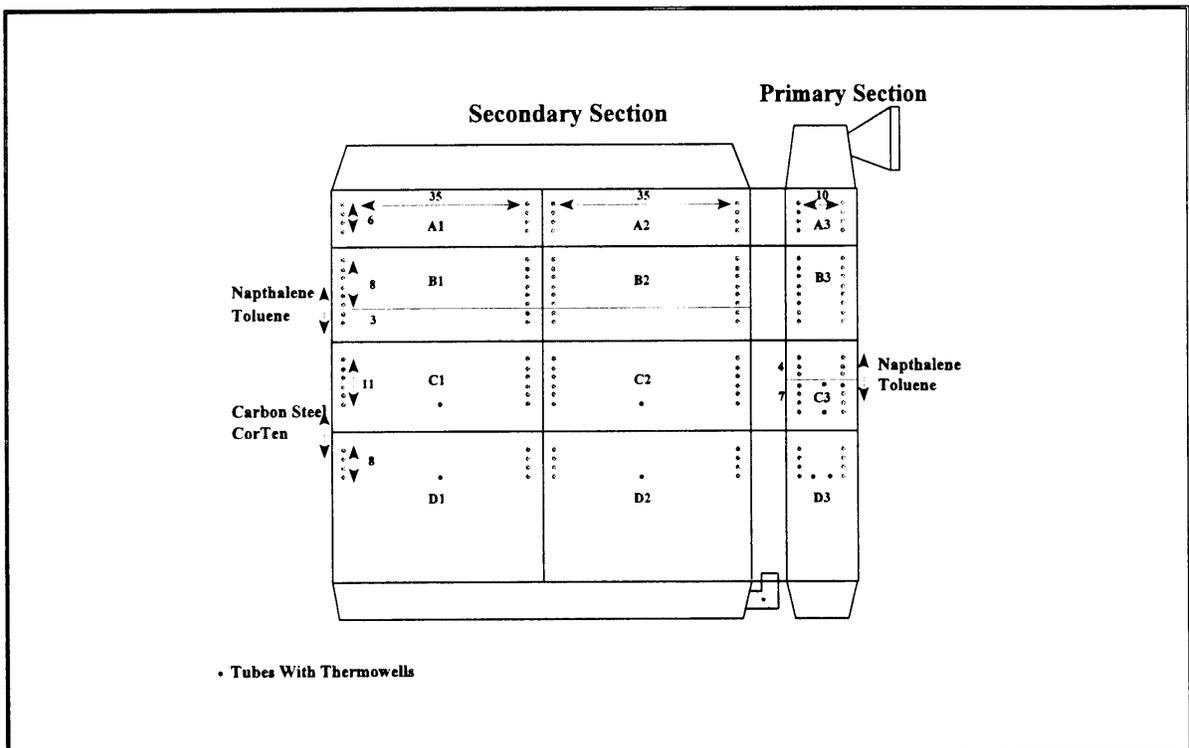
**Figure 7.** Tube layout and thermowell locations for the Milliken heat pipe air heaters.

primary air rate through the air heater or the primary flue gas damper position. The other TCs are in areas where tube corrosion is a concern. Three TCs are located in the coldest CS heat pipes (last row of Modules C1, C2, and C3) and four TCs are located in the cold-end heat pipes (last row of Modules D1, D2, and D3).

Stream	TC/Array
Flue Gas In	10
Flue Gas Out	6
Secondary Air Out	6
Secondary Air In	4
Primary Air In	2
Primary Air Out	2

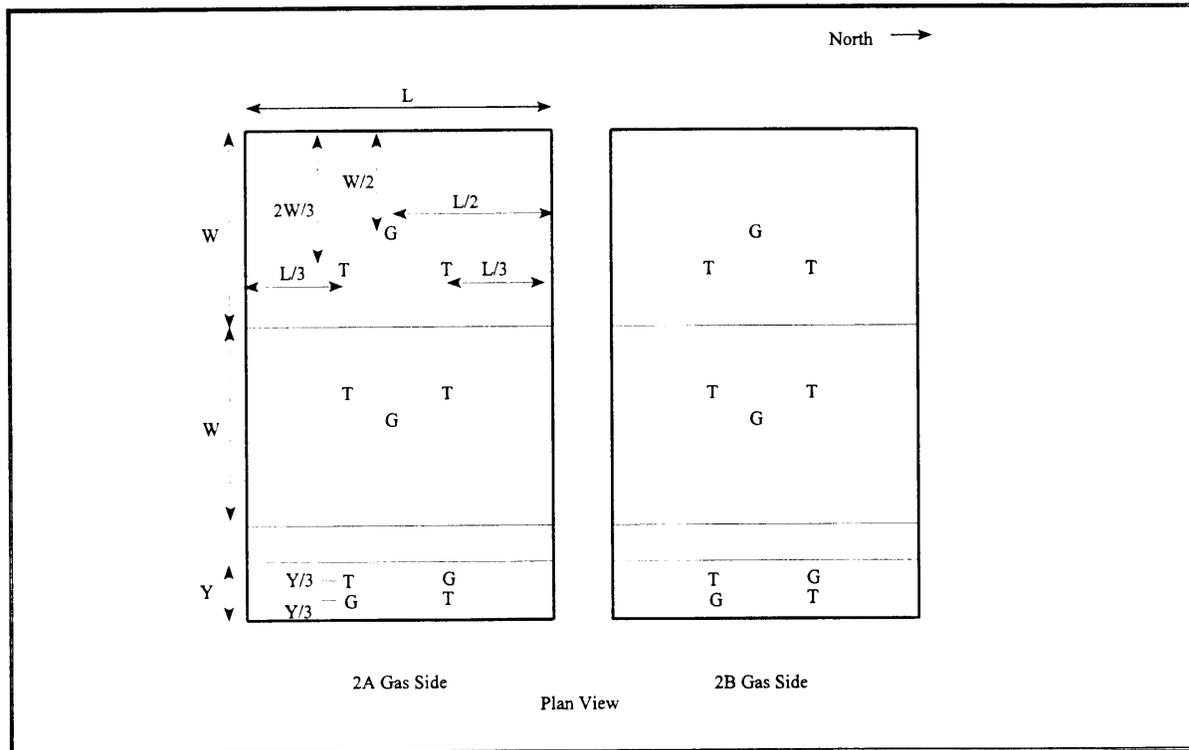
**Figure 8.** Cold-end tube (skin) and flue gas TC locations.

After the air heaters were in operation, additional TC instrumentation was installed in the outlet cold-end modules to help monitor fouling behavior. Six heat pipe skin TCs were installed in each heat pipe air heater (Figure 8). This was done by grinding the fins off a small area of a tube and then

gluing a sheathed TC to the tube using a heat transfer cement. For comparison, four flue gas TCs were located near the skin TCs; two gas TCs in the primary flue gas section and two gas TCs in the secondary flue gas section. Monitoring of these TCs provided an on-line means of estimating where fouling was most severe in each heat pipe.

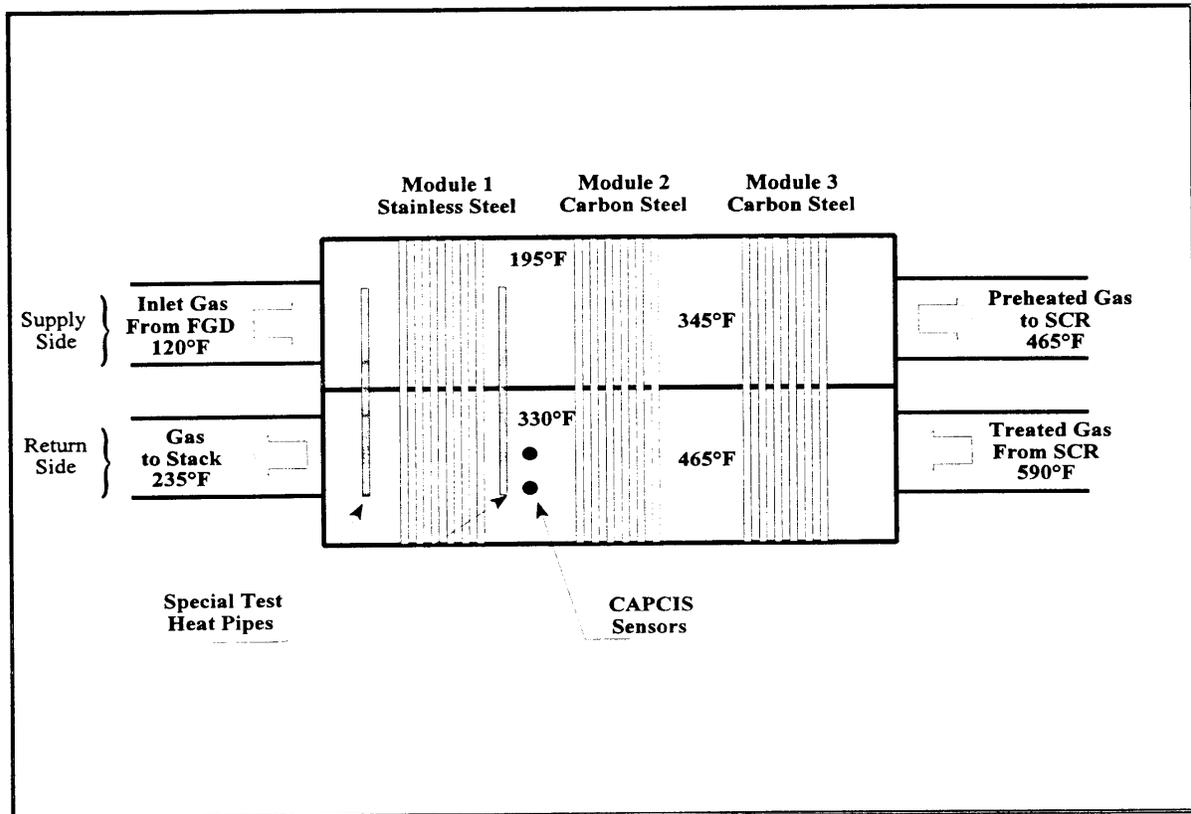
**Figure 9.** Plan view of ECTC heat pipe heat exchanger.

Although corrosion of the heat pipes was experienced on both the supply and return sides, only the return side corrosion will be discussed. This is the only area where the corrosion results are relevant to the design of the Milliken air heaters.

To monitor corrosion rates during individual tests, two electrochemical CAPCIS corrosion probes were installed on the return side between modules 1 and 2. One probe was made of SA-178A CS and the other from Cor-Ten B. The probe instrumentation incorporates the use of electrochemical impedance measurement (EIM), electrochemical potential noise (EPN), electrochemical current noise (ECN), and zero resistance ammetry (ZRA). Changes in these electrical responses are used to determine the corrosion rate in real time and can be used to determine the type of attack (uniform or localized). A description of the measurement techniques can be found in Reference 1.<sup>1</sup>

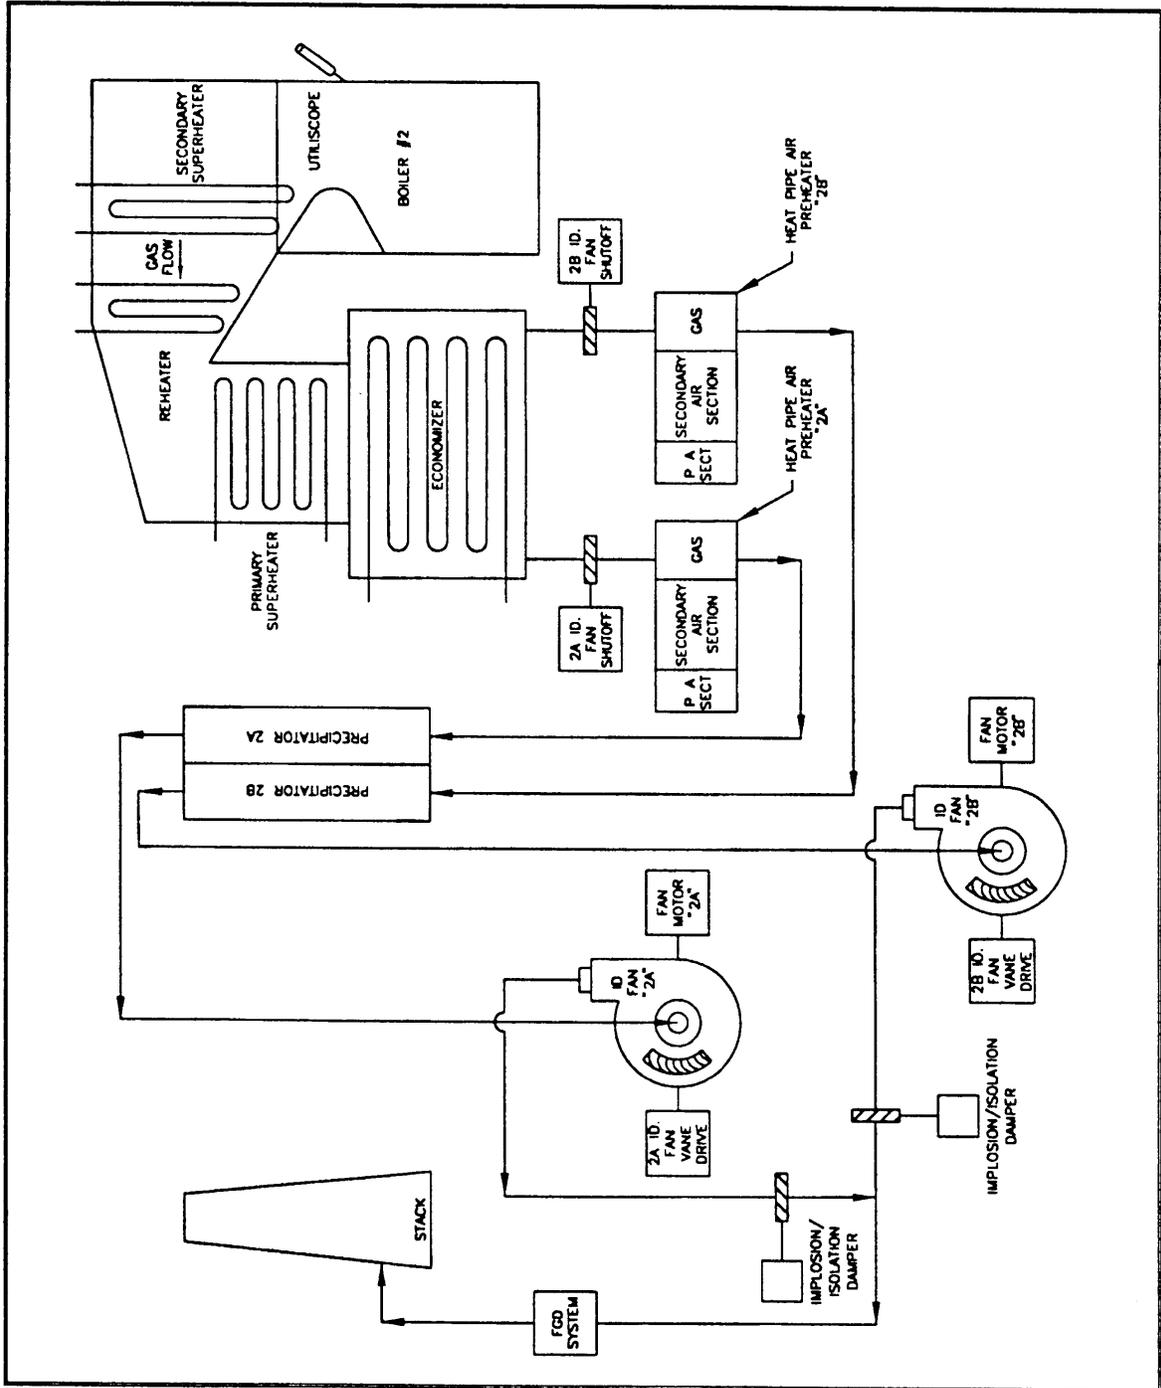
Figure 10. Unit 2 Induced draft system.

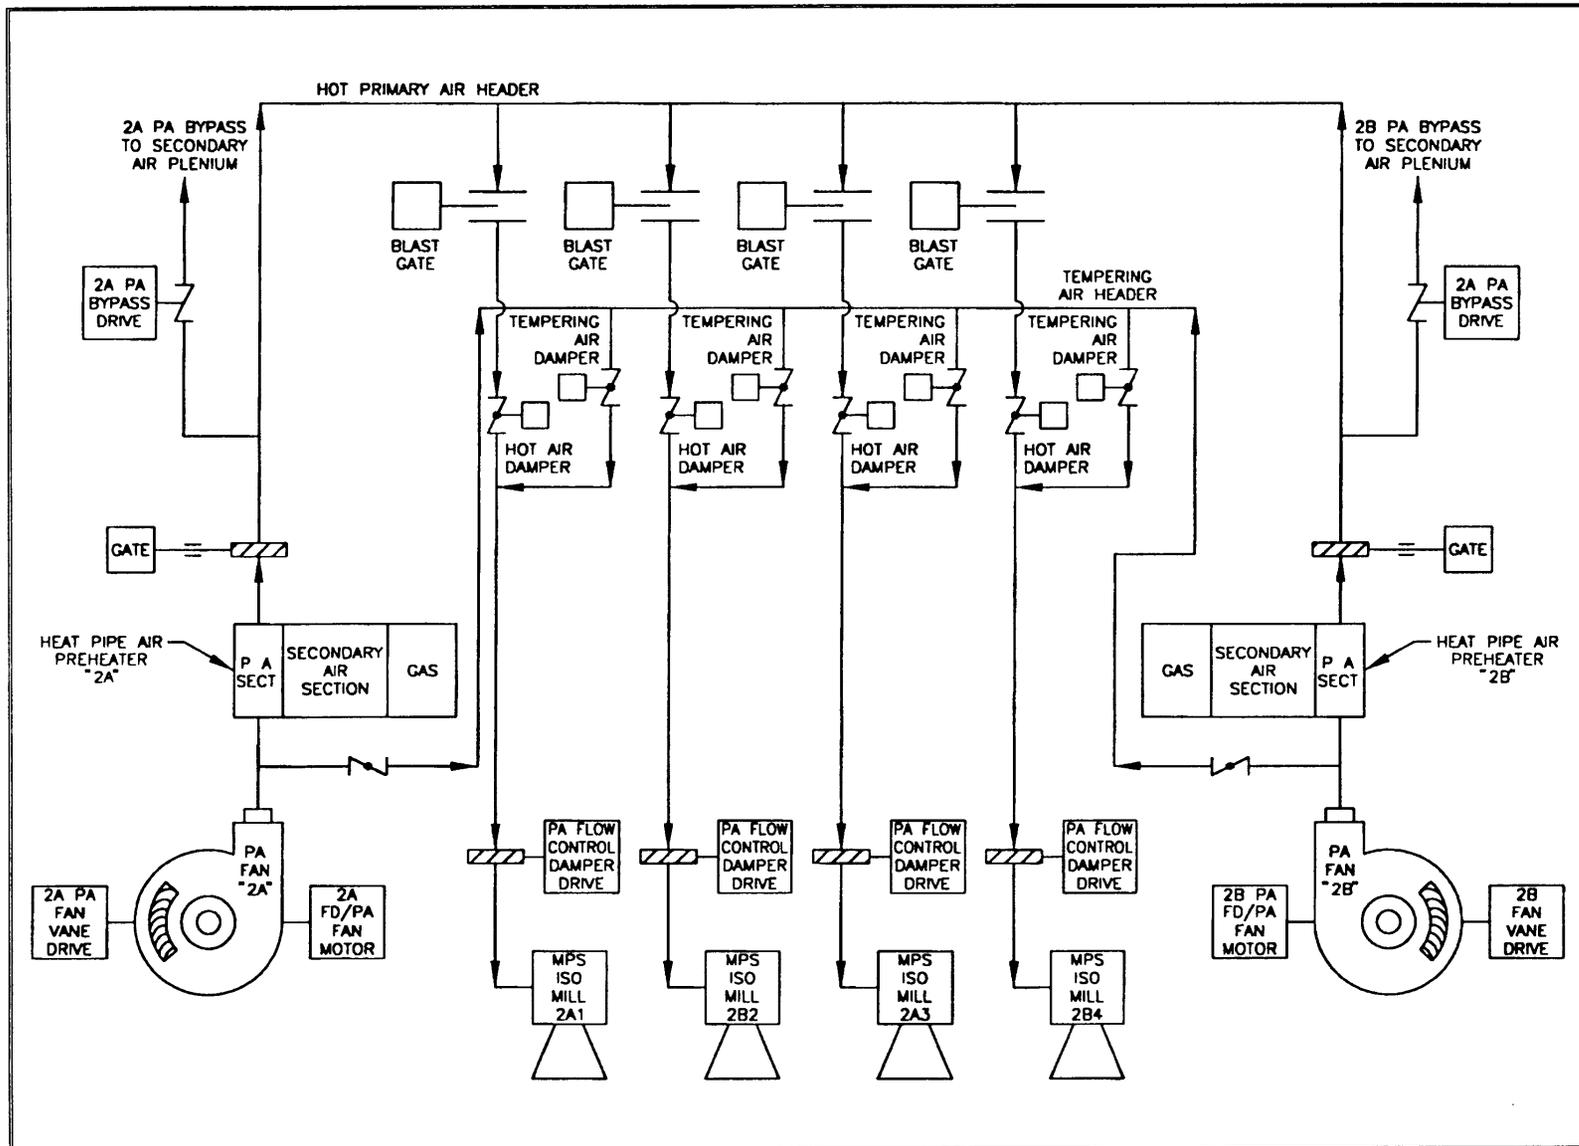
Figure 11. Unit 2 primary air system.

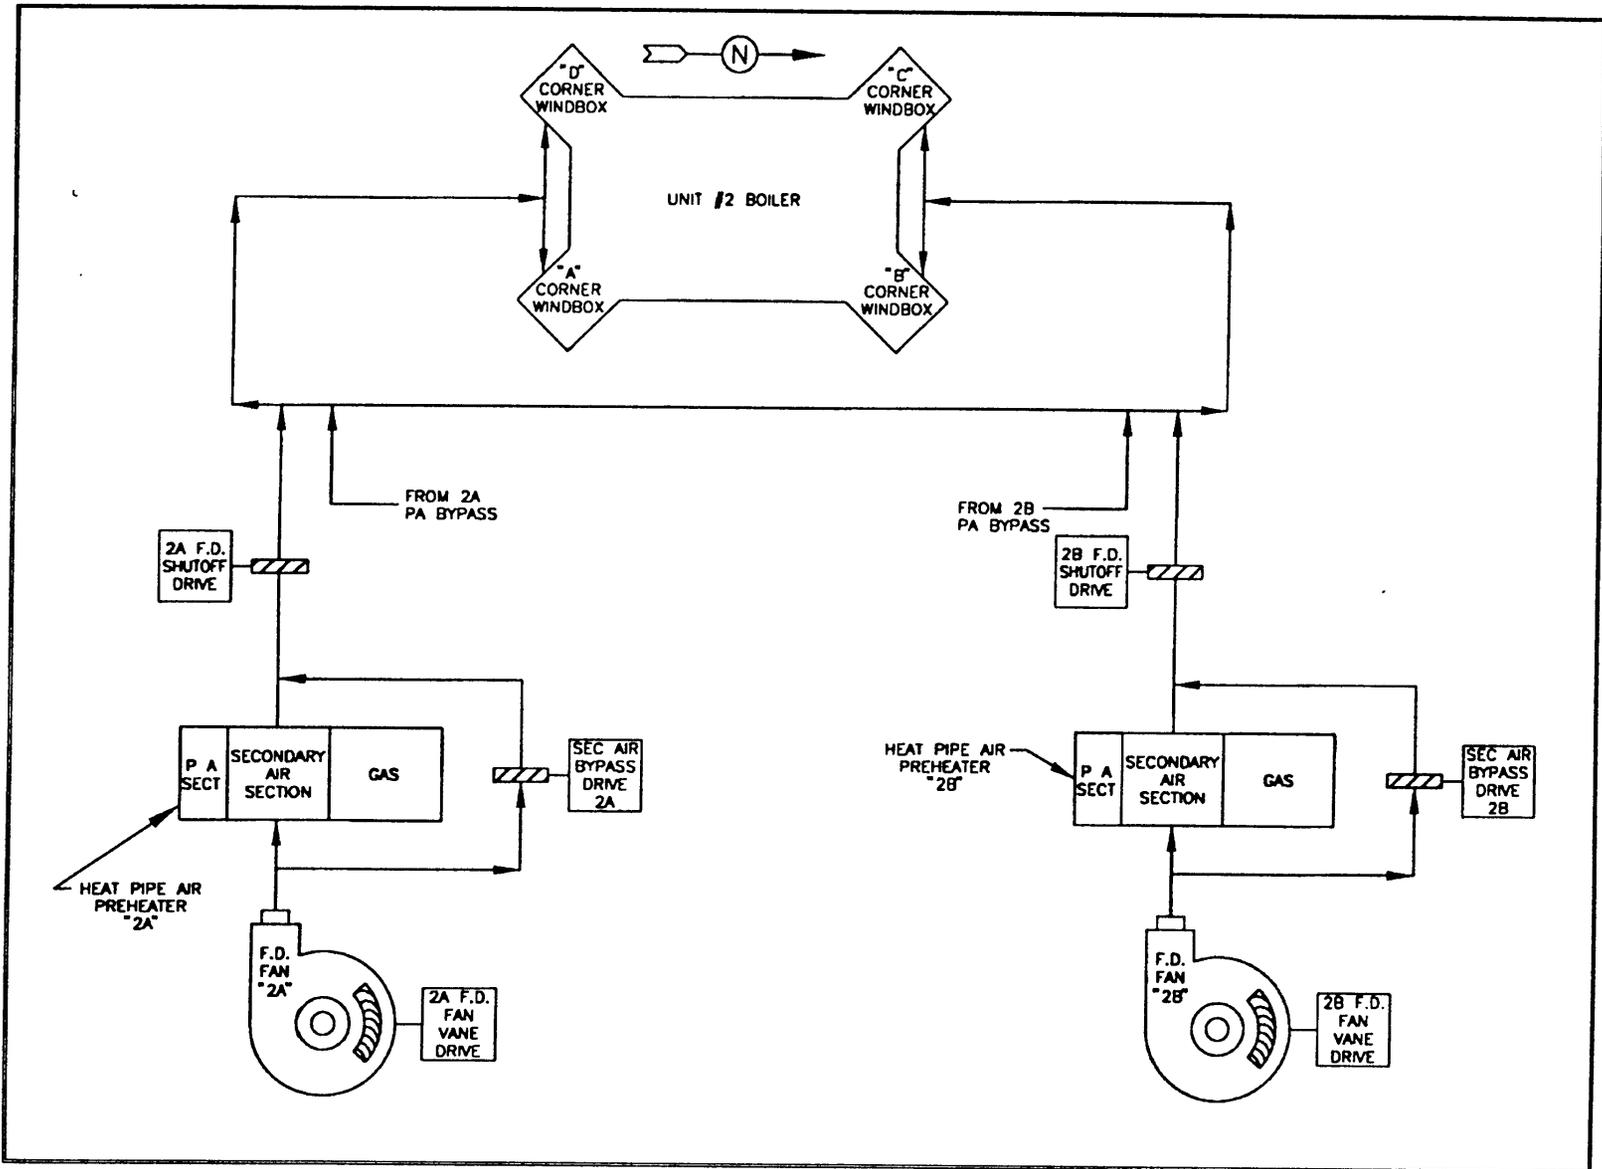
Figure 12. Unit 2 forced draft (secondary air) system.

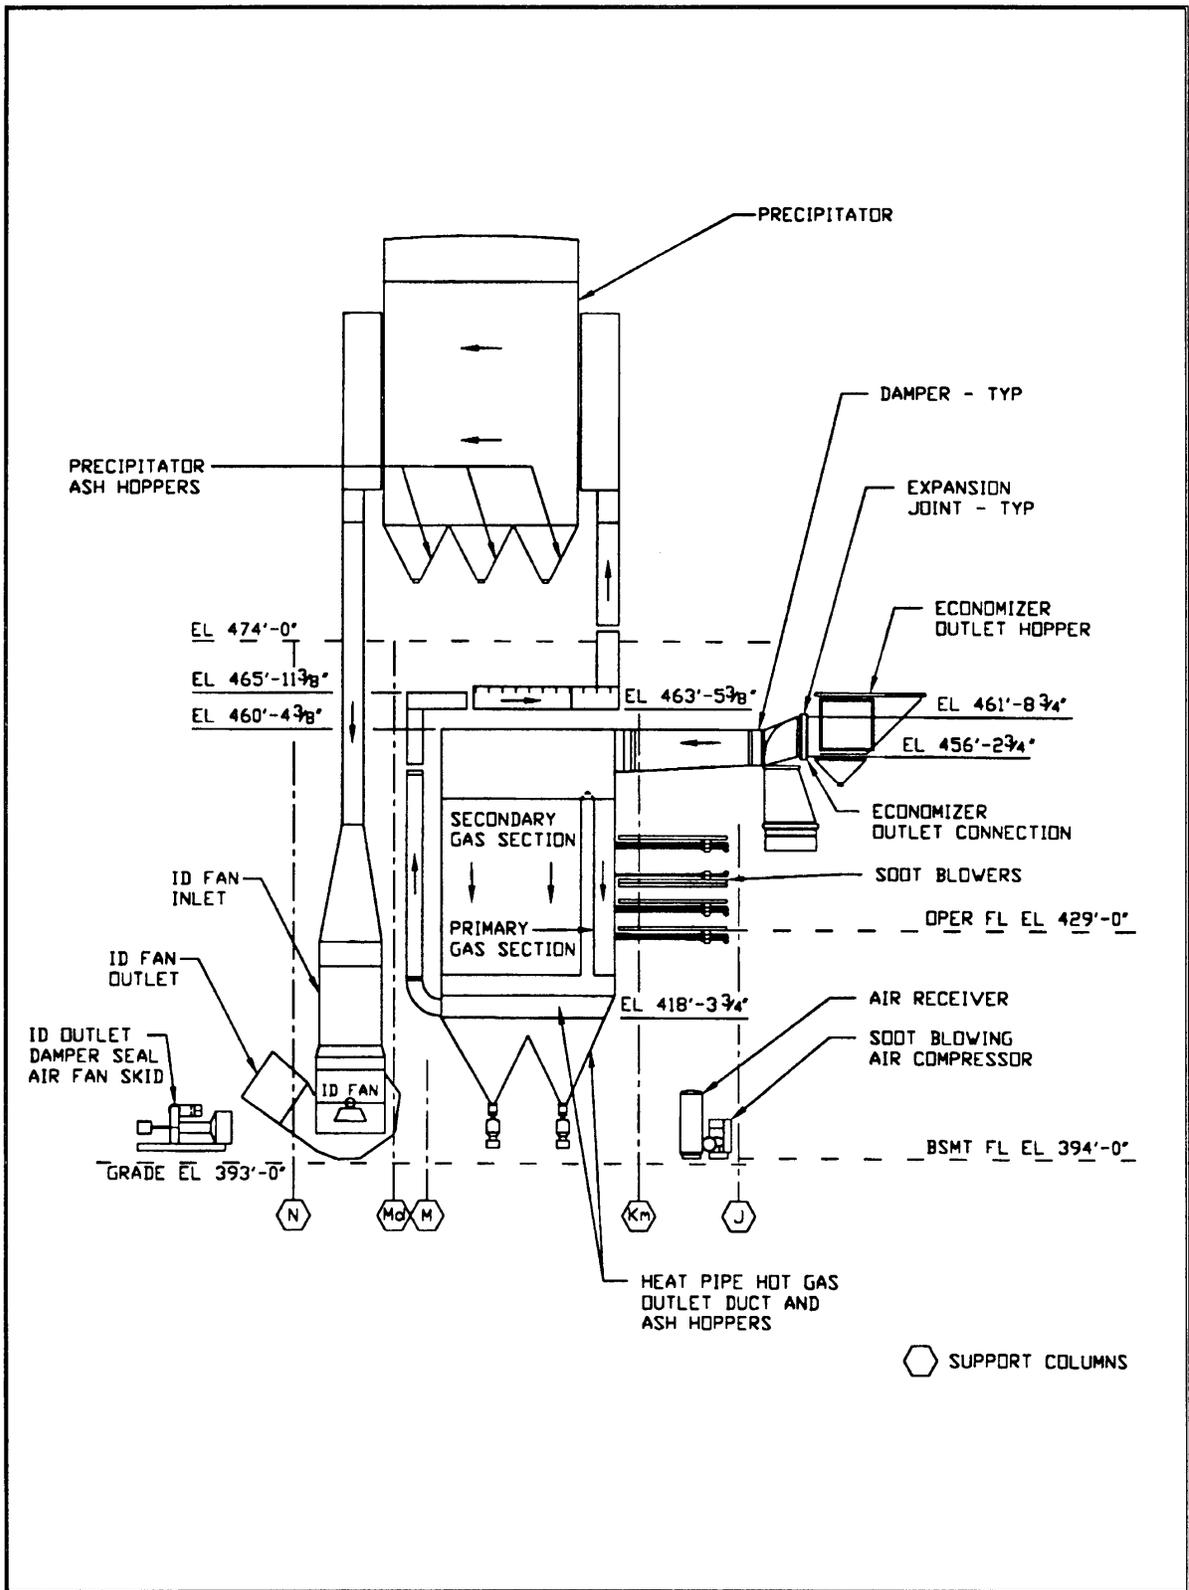
Figure 13. Heat pipe equipment layout -- flue gas section.

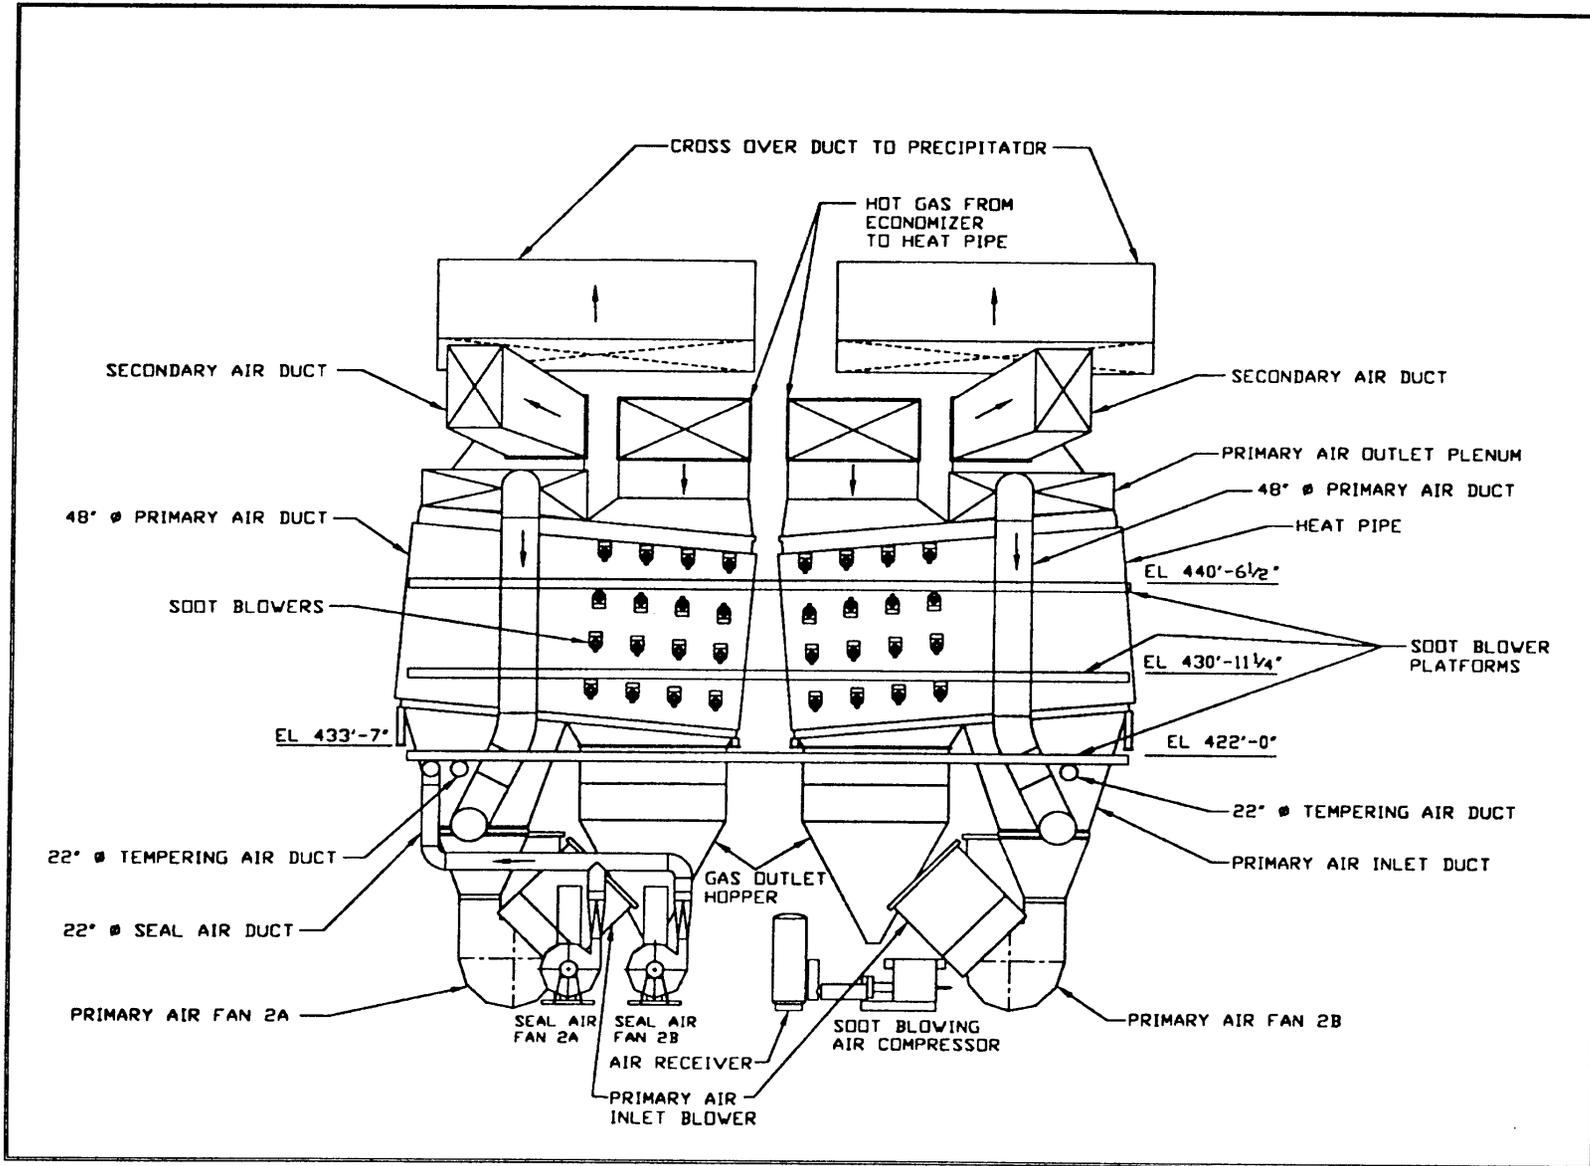
Figure 14. Front view (looking west) of heat pipe air heaters.

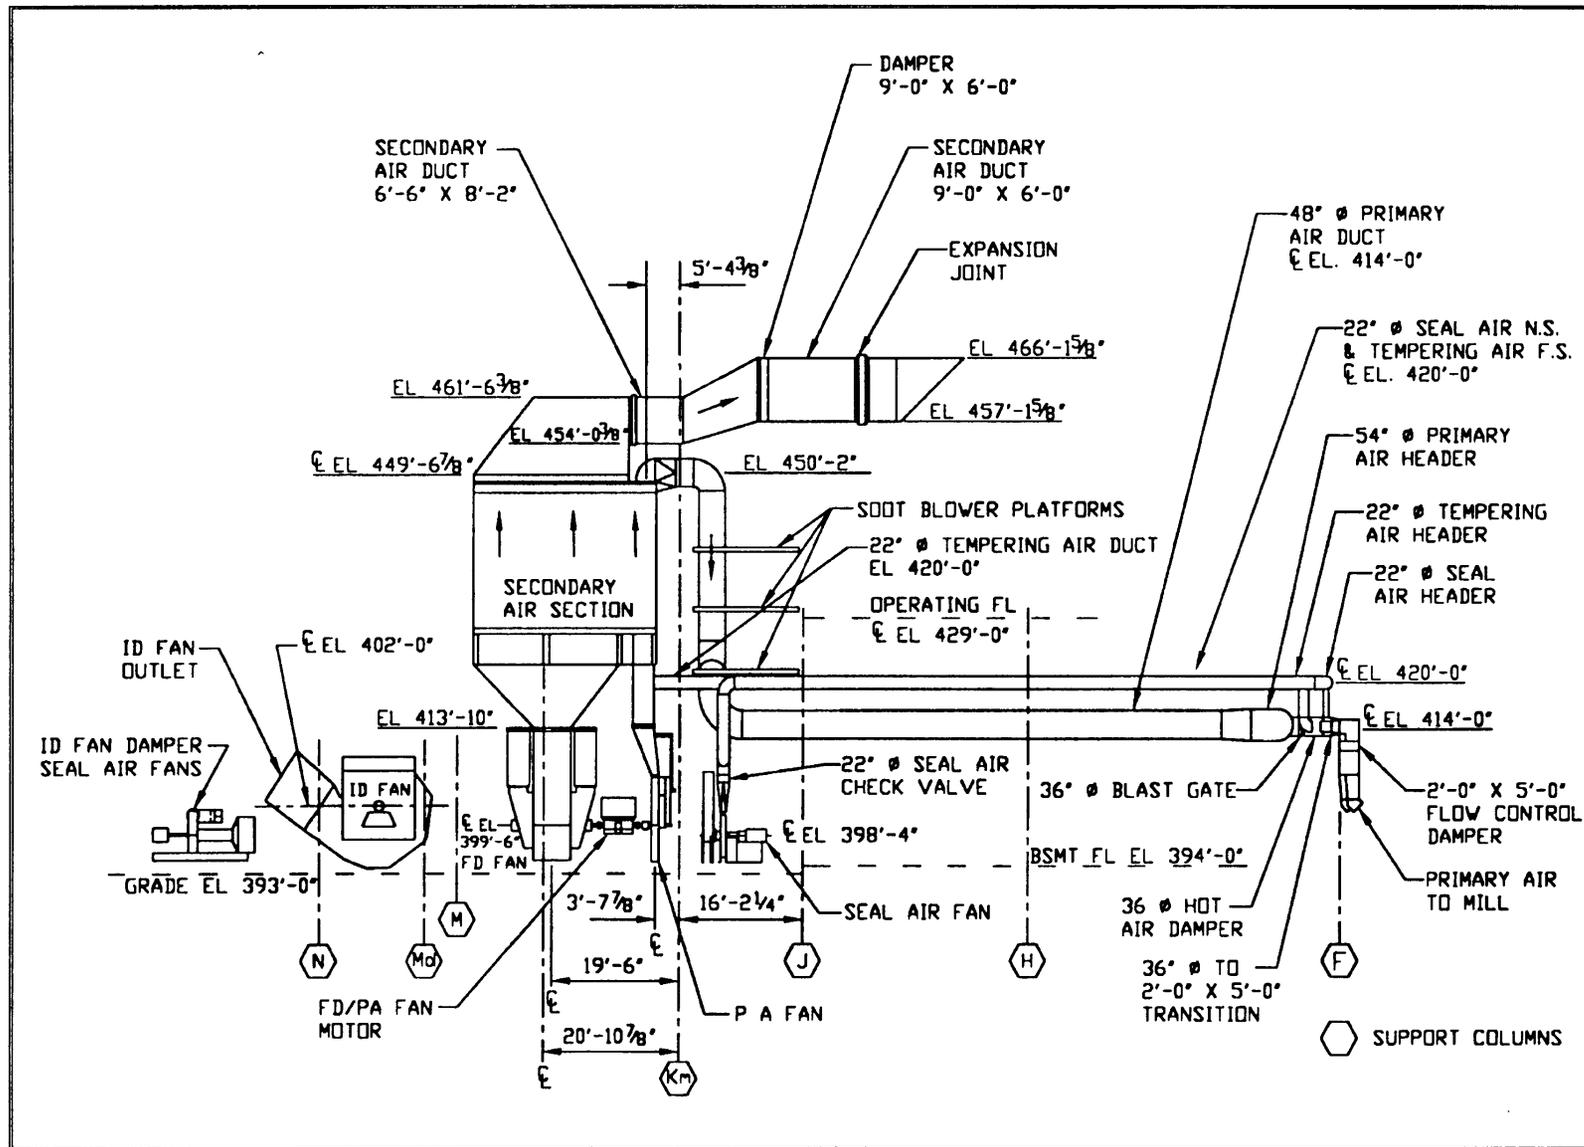
Figure 15. View (looking north) of heat pipe air sections.

Figure 15 is a northward facing view of the unit showing the primary and secondary air duct system. The view shows the PA and FD fans and the common motor. Placing the PA and FD fans directly below the heat pipes allows use of short expanding ducts between the fan discharges and the heat pipe connection flanges. An isometric view of the system is presented in Figure 16.
